Manhole Inspection Summary

Manhole # S41A2_019MH

Insp Date: **4/18/08 1:30 PM**

Location Address: **3812 Brooklyn Ave.**

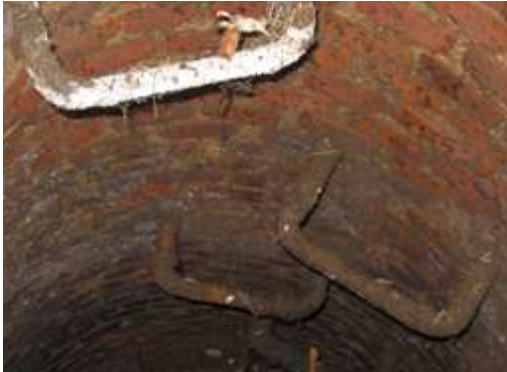
Steps Count: **5** Missing: **0** ☒ **Corroded**

steps

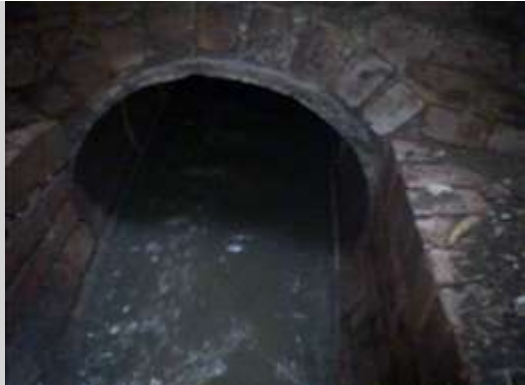
12 O'Clock Outflow

21 in. Circular Gravity Sewer
Pipe Out @ 12 O'Clock

Pipe Height: **19.2** (in.) Rod and Bar (Angled)
Pipe Material: **Clay** ☐ Pipe Lined
Invert Depth: **10.60** (ft.) Flow Characteristics: **Slow**
Deposits: ☒ None ☐ Mud ☐ Sludge ☐ **Debris** ☐ Grease
Silt Depth: (in.) Deposits Extent:
Infiltration: **None** Pipe Seal Cond: **Sound**

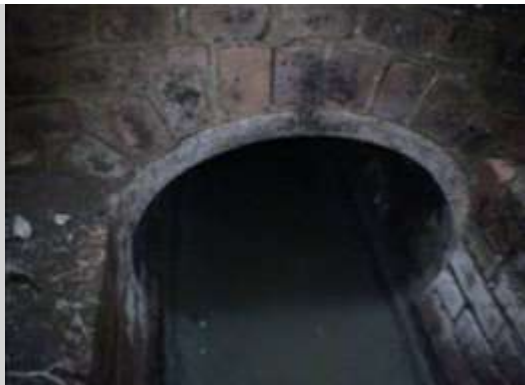
6 O'Clock Inflow

21 in. Circular Gravity Sewer
Pipe In @ 6 O'Clock

Pipe Height: **19.2** (in.) Rod and Bar (Angled)
Pipe Material: **Clay** ☐ Pipe Lined
Invert Depth: **10.42** (ft.) Flow Characteristics: **Slow**
Deposits: ☒ None ☐ Mud ☐ Sludge ☐ **Debris** ☐ Grease
Silt Depth: (in.) Deposits Extent:
Infiltration: **None** Pipe Seal Cond: **Sound**

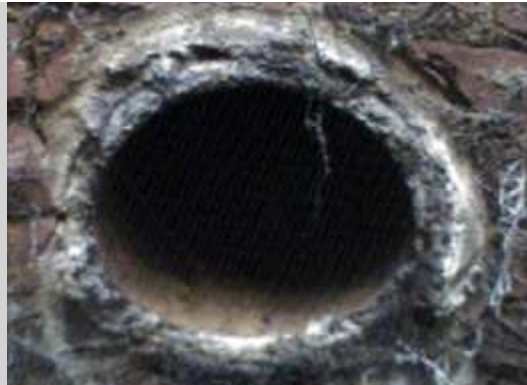
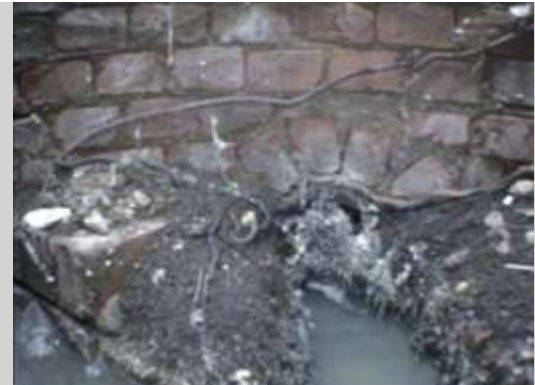
9 O'Clock Inflow

8 in. Circular Gravity Sewer

Deposits: ☐ None ☐ Mud ☐ Sludge ☒ **Debris** ☐ Grease

Silt Depth: **6** (in.) Deposits Extent: **Heavy**

Drop Condition: **Partly Clogged**
